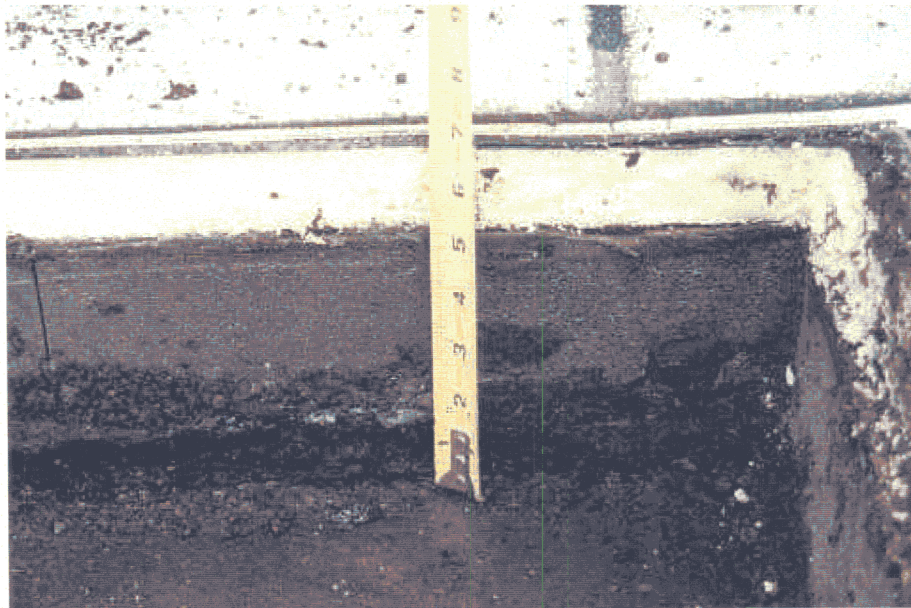
Figure 2.6-21 Inspection Opening No. 2

- f. Three-ply built-up roofing (asphalt).
- g. Three-inch thick rigid foamglass insulation (with wet paper facers).
- h. Asphalt mopping layer.
- i. Approximately 1/2-inch thick layer (tapered) All-Weather Crete asphalt/perlite fill (wet).
- j. Concrete roof slab (surface slightly uneven).

As shown in Figure 6.2-21, the existing construction on the west side of the opening consists of the following (from top to bottom):

- a. Approximately four layers of elastomeric coating (includes base, intermediate, and several finish coats), minor small pock marks in top surface layer.
- b. Granular surfaced modified bitumen membrane (set in cold adhesive).
